Special Issue of First International Conference on Management, Science and Technology (ICMST 2021)

## Fault detection for recycled rubber and glass material implementation via digital image processing

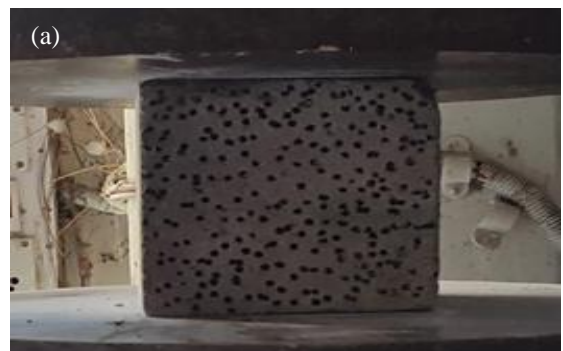
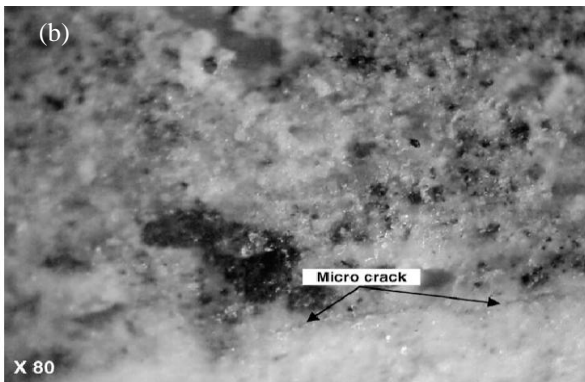
**Fig. 1. (a) Compression load; (b). Micro crack in the structure under the load**

The characteristic of stress concentration may result in cracks generated by external stimulation on a material that possesses flaws. The stress concentration behavior generates local buckling, which damages the material's members. Therefore, research needs to discover strategies to control the strain fluctuation of a broken part. The old technology can only assess a region's average strain[22]. Unable to establish the strain variance inside this location. Therefore, the mechanical behavior around the crack cannot be adequately reflected. The newly created digital image association approach is an imaging method for assessing the distortion of objects[14]. This methodology may correlate an object's digital photographs before and after distortion and further determine the object's displacement and pressure fields based on the respective position on the picture.

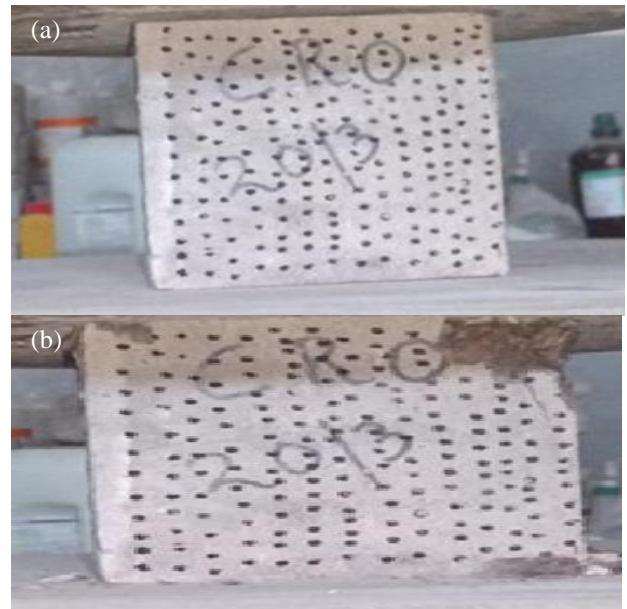
**Fig. 2. Speckle pattern marked cube (a) without applying any load; (b) with ultimate loading**

Gradually increasing load generates cracks in cubes. The microstructure of specimen surface showing cracks in above Fig. 2(a). The DIP method was utilized to measure the 2D surface shifts and strain of a concrete cube. On the specimen surface, the speckle pattern was developed for DIP. During the exam, specific selective photographs were obtained, and the mathematics tool was used. Few photos were selected for DIP analysis from the photos collected during loading and unloading. For correlation, a square grid design was taken into account. Using the strain obtained from DIP, stress acting on the concrete cube was calculated using a reduction factor of 5. The reduction factor depends upon the grid size used during the process. From Fig. 3(b) maximum strain obtained is  $8 \times 10^{-3}$ . It indicates that the predicted value (DIP) is approximately equal to the observed value.

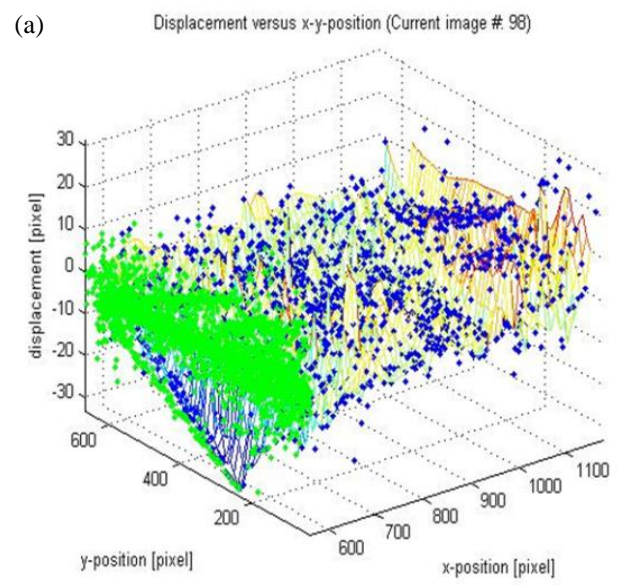
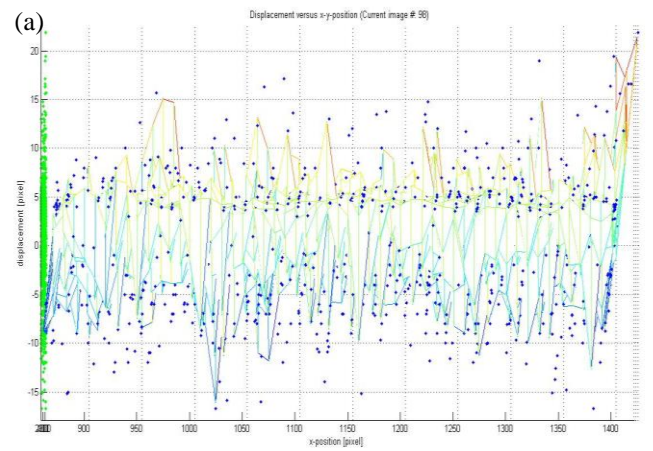
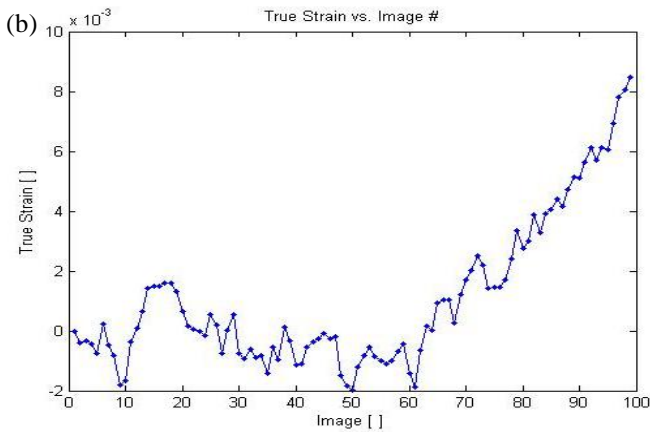
**Fig. 3. (a). 3D surface displacements diagram for control mix cube; (b) True strain v/s images graph for control cube**

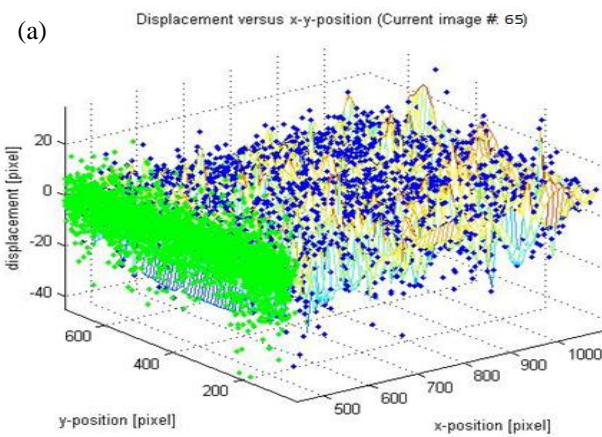
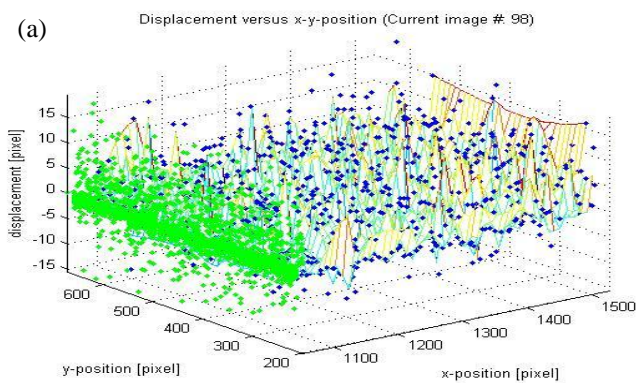
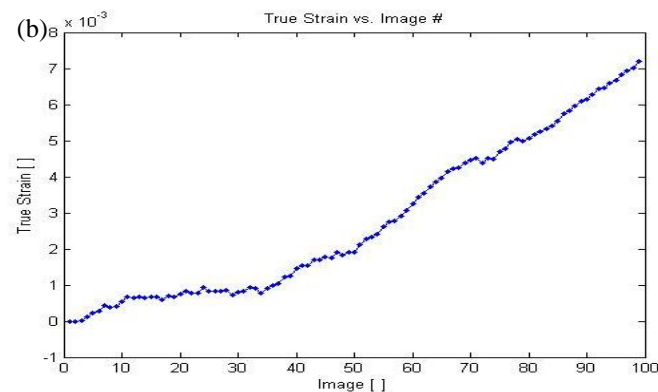
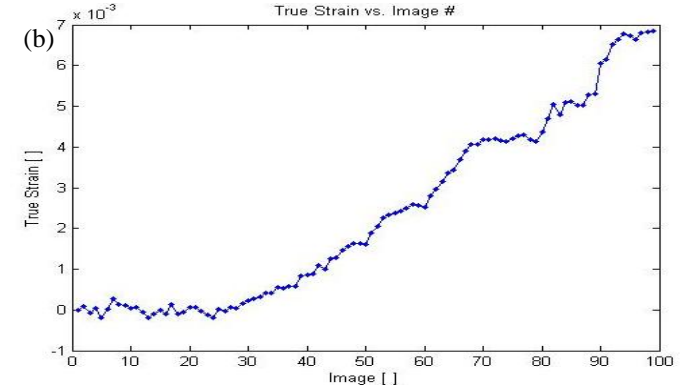
**Fig. 4. (a) Displacement plot for the cube with 4% rubber, (b) True strain v/s images graph for the cube with 4% rubber**

The fine aggregates in the concrete cube are replaced by waste material as crumb rubber by 4% (by weight). It presents a sample with a crack generation. Few pictures are depicted in the photographs obtained during loading and unloading. A grid layout for correlation was considered. Fig. 4(a) shows surface displacement, and Fig. 4(b) shows strain plots at different stages of loading. From Fig. 4(b) maximum strain obtained is  $7.1 \times 10^{-3}$ . The displacement to strain and strain to stress acting on the concrete cube was calculated using a reduction factor of 5. The reduction factor depends upon the grid size used during the process. This shows that the forecast value (DIP) is approximately equal to the experimental value. On concrete cube specimens, the DIP test was conducted. This staged process growing stress contributed to the creation of cracks in cubes. The measurement of 2D surface deformations and strain for a cube specimen is done using optical technology (DIP technology). On the specimen surface, the speckle pattern was developed for DIP. During the exam, specific selective photographs were obtained, and the mathematics tool was used. Few photos were selected for DIP analysis from the photos collected during loading and unloading. The fine aggregates in the concrete cube are replaced by waste material as crumb rubber by 5% (by weight) out of the images taken during loading and unloading. The maximum strain obtained  $6.9 \times 10^{-3}$ . Using the strain obtained from DIP, stress acting on the concrete cube was calculated using a reduction factor of 5. The reduction factor depends upon the grid size used during the process. The fine aggregates in the concrete cube are replaced by waste material as glass by 18% (by weight), out of the images taken during loading and unloading. A square grid

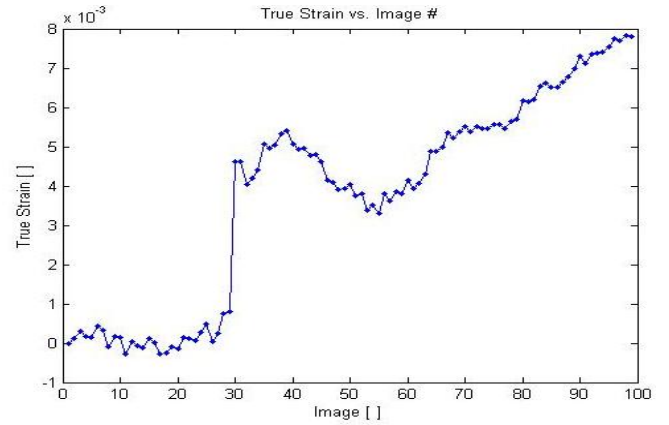
**Fig. 7. (a) Displacement plot for the cube with 20% glass; (b). True strain v/s images graph for the cube with 20% glass**

The fine aggregates in the concrete cube are replaced by waste material as glass by 20% (by weight). Out of the images taken during loading

and unloading, as square grid pattern has been considered for correlation. Fig. 7(a) shows surface displacement, and Fig. 7(b) shows strain plots at different stages of loading. Fig. 7(b) maximum strain obtained is  $7.9 \times 10^{-3}$ , the strain obtained from DIP, stress acting on concrete cube was calculated using reduction factor of 5. The fine aggregates in the concrete cube are replaced by waste material as glass by 21% (by weight). A square grid pattern has been considered for correlation. Fig. 8(a) shows surface displacement, and Fig. 8(b) shows strain plots at different stages of loading. The propagation of the crack with the increase and maximum strain obtained is  $6.9 \times 10^{-3}$ . Using the strain obtained from DIP, stress acting on the concrete cube was calculated using a reduction factor of 5. The reduction factor depends upon the grid size used during the process. With the addition of 19% of glass waste used in concrete, its durability enhanced. The load value at the end of the test may be a quantifiable metric. The remarkable non-linear correlation from the fibre content to the limit load may be detected.
