Structural Assessment Material and Fire Induced Strength Degradation Material of Multistory Building

Abstract

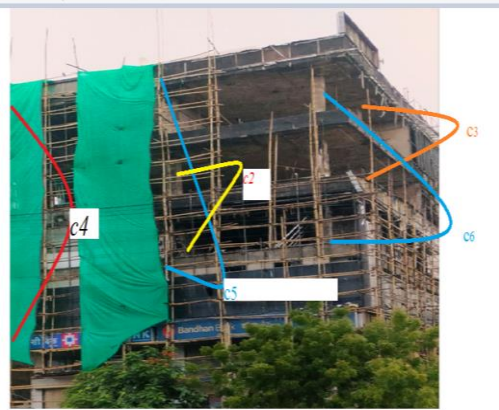
**Figure 2 External View of Building during Firing Timing**

The deterioration of concrete strength due to fire at elevated temperatures profoundly affects the structural integrity of buildings [7], [8]. It is imperative to conduct research on the residual mechanical properties following fire exposure to accurately evaluate structural strength [9]. Investigations into concrete strength under fire conditions indicate a decline in compressive strength, with higher grade concrete demonstrating superior resistance to elevated temperatures [10]. Studies analyzing the impact of fire on reinforced concrete structures reveal a significant decrease in both load resistance and deformation capacity with prolonged exposure to fire [11]. Additionally, a study focusing on bond behavior in reinforced concrete members postfire emphasizes the critical importance of assessing residual bond strength to ensure structural safety in the aftermath of a fire. Understanding the mechanisms underlying structural degradation and resilience in fire conditions is essential for the design of more resilient buildings. At the time of the fire, the media captured images of the building, which are presented in Figure 2.

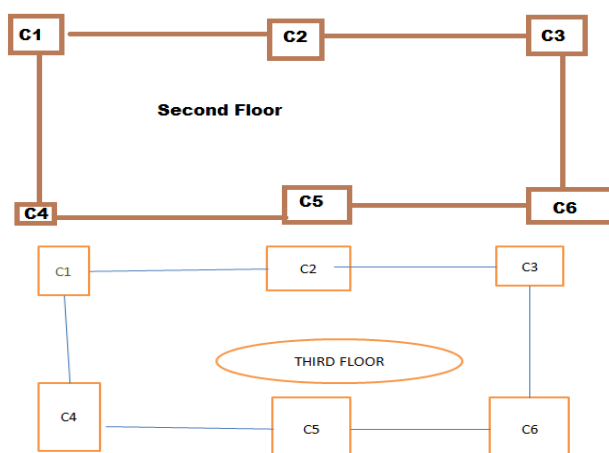
Figure 4 Plan for the Second and Third Floors

The building's columns, particularly in C5, C6, and C4, incurred the majority of losses primarily due to extensive fire damage, as visually assessed [12]. The duration of the fire directly correlated with the temperature reached, notably impacting the third and fifth floors, which bore direct harm from the flames [13]. Fire safety engineering principles underscore the crucial importance of comprehending the effects of fire to mitigate casualties and property damage [14]. Studies on structural behavior under fire induced progressive collapse scenarios reveal a significant decrease in load resistance when the fire duration exceeds 30 minutes, with critical failure points identified based on the duration of the fire [15]. The implementation of a systematic evacuation system, tailored to the building's characteristics, can effectively minimize casualties in fire incidents, underscoring the significance of establishing appropriate evacuation routes for swift and safe evacuation [16]. Figure 3 shows External View of Post Fire Building. Figure 4 shows Plan for the Second and Third Floors

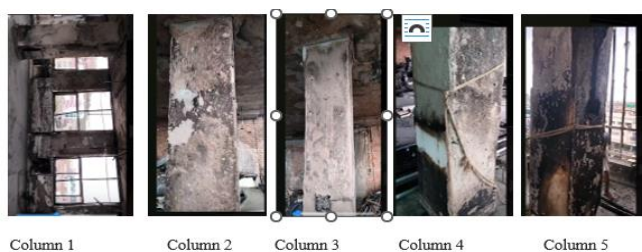
Figure 6 Column 1 to Column 5

The figures primarily depict the condition of column 5 and subsequently showcase the condition of column 4 on floor 2. These visual representations provide a clear depiction of the structural integrity of the columns following the fire incident, offering valuable insights into the extent of damage and deterioration incurred. The primary objective of this paper was to assess the strength of columns

subsequent to fire exposure. By analyzing the conditions of columns on floors 3 and 4, we aimed to elucidate the effects of fire induced damage on structural elements and inform strategy for structural repair and reinforcement. Figure 6 shows Column 1 to Column 5 and Figure 7 shows Condition of The Column on Floor 4

Column	Color on column	Approximate temperature
1		The reinforcement became visible due to concrete spalling, though slight soot deposition without significant color change was noted, but a light pink hue indicated exposure to elevated temperatures.
2		The partially intact column showed a light pink or reddish color with phenolphthalein spray, indicating a temperature of 500°C.
3		The phenolphthalein test showed a dark pink-reddish color, indicating an approximate temperature of 500°C.
4		The column showed severe deterioration, with a light pink color from the phenolphthalein indicating a temperature range of approximately 0–600°C.

5		The column had soot deposition, and a light pink color from phenolphthalein indicated temperatures around 300–400°C.
6		The column's external structure was damaged, showing no color change with phenolphthalein, indicating around 400°C, while soot deposition yielded a light pink color, suggesting 300–400°C.

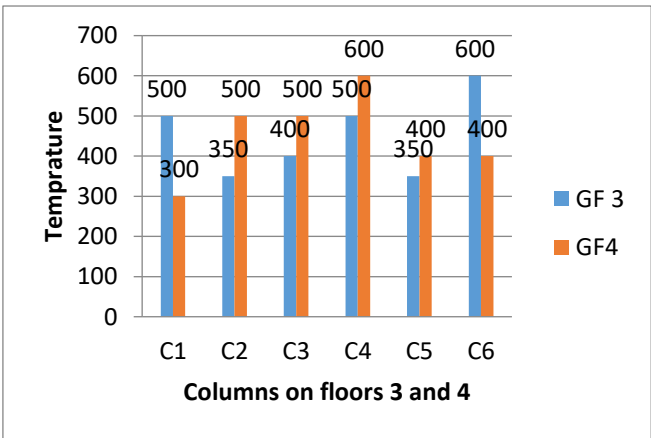
Figure 8 Temperatures on Each Column after Firing on F3 and F4

Statement could be presented as follows: Data collection from the building revealed variations in temperature across different columns on floors 3 and 4, resulting in varying strength levels. The concrete used was of grade M25 MPa, and the observed strength reduction was consistent with the specifications for this grade, decreasing with higher temperatures according to ISO 834 and Eurocode Part 2. Figure 8 shows Temperatures on Each Column after Firing on F3 and F4.

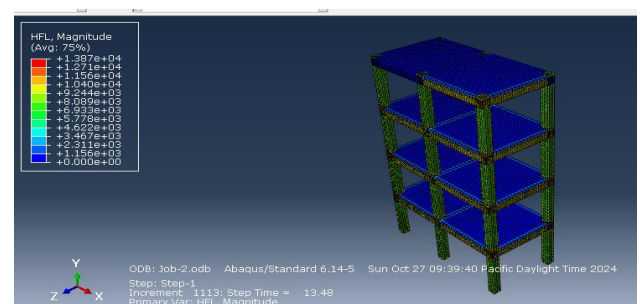
Figure 9 Heat Flux Values

As shown in Figure 9, The same model was analyzed using Abaqus software to simulate the heat flux values and temperature for each color zone, with results closely aligning with the experimental data.

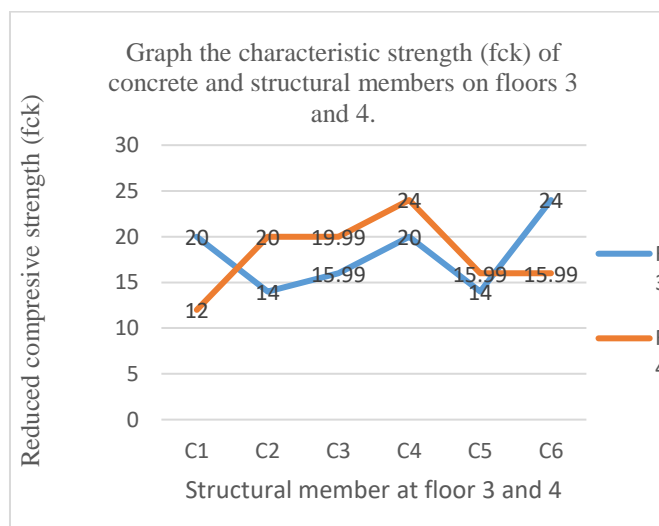
Figure 10 Comparison of Residual Strength between Columns on Floors 3 and 4

Overall, the residual strength on Floor 4 tends to be higher than the reduced strength on Floor 3, with varying differences across the columns. Tables 7 shows Degradation of Strength Due To Different Temperature of Column at Different Column of F 4. Table 8 shows Heat Flux, Color Codes, and Temperatures

The analysis of strength reduction and residual strength across the columns reveals significant insights into the structural performance under fire exposure. C1 and C6 demonstrate notable resilience, maintaining higher residual strengths (60% and 80%, respectively) despite experiencing reductions of 33.33% and 53.44%. This indicates effective performance in withstanding thermal stress. C2, C3, C4, and C5 exhibit higher strength reductions, with C2 showing the most significant reduction (53.33%) alongside a residual strength of only 33.33%. This suggests potential vulnerabilities in the structural integrity of these columns. Overall, the residual strength on Floor 4 is generally higher than the reduced strength on Floor 3, highlighting varying performance levels across the columns. The results emphasize the importance of assessing both strength reduction and residual capacity to ensure the safety and reliability of concrete structures subjected to fire. These findings underscore the need for further investigation into enhancing fire resistance in structural design, particularly for elements exhibiting substantial strength reductions.
